Manhole Inspection Summary

Manhole # **S13GG_006MH**

Insp Date: **7/10/08 2:46 PM**

Location Address: **REAR OF 1605 ST STEPHENS**

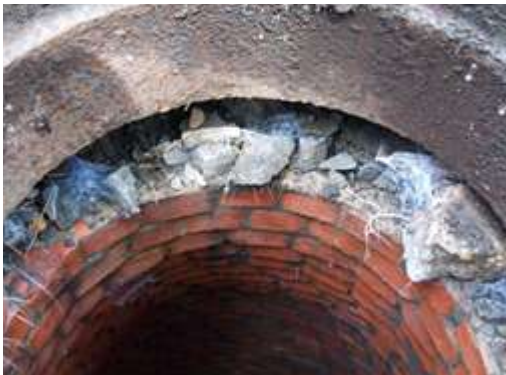
Defect 3

Condition: ☐ Sound ☐ Cracked ☐ Root Intrusion ☒ **Loose Brick** ☒ **Deteriorated**

CHIMNEY LOOSE BRICKS

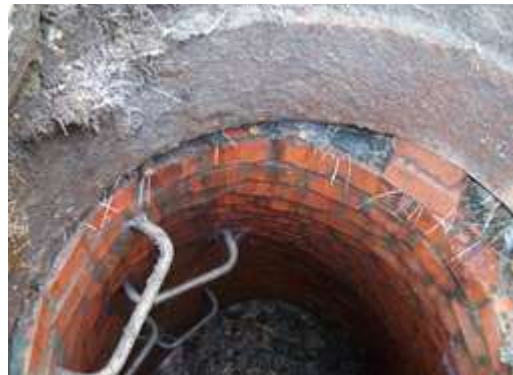
Defect 2

DETERIORATED CHIMNEY

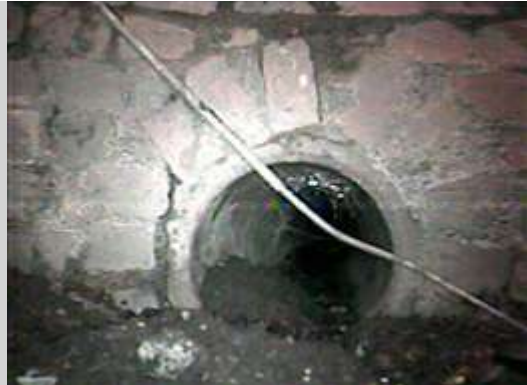
12 O'Clock Outflow

8 in. Circular Gravity Sewer
Pipe Out @ 12 O'Clock

Deposits: ☐ None ☐ Mud ☐ Sludge ☒ **Debris** ☐ Grease

Silt Depth: **1** (in.) Deposits Extent: **Light**
